REPORT ON FUEL-PLATE MELTING

AT THE OAK RIDGE RESEARCH REACTOR JULY 1, 1963

ORNL-TM-627

OPERATIONS DIVISION

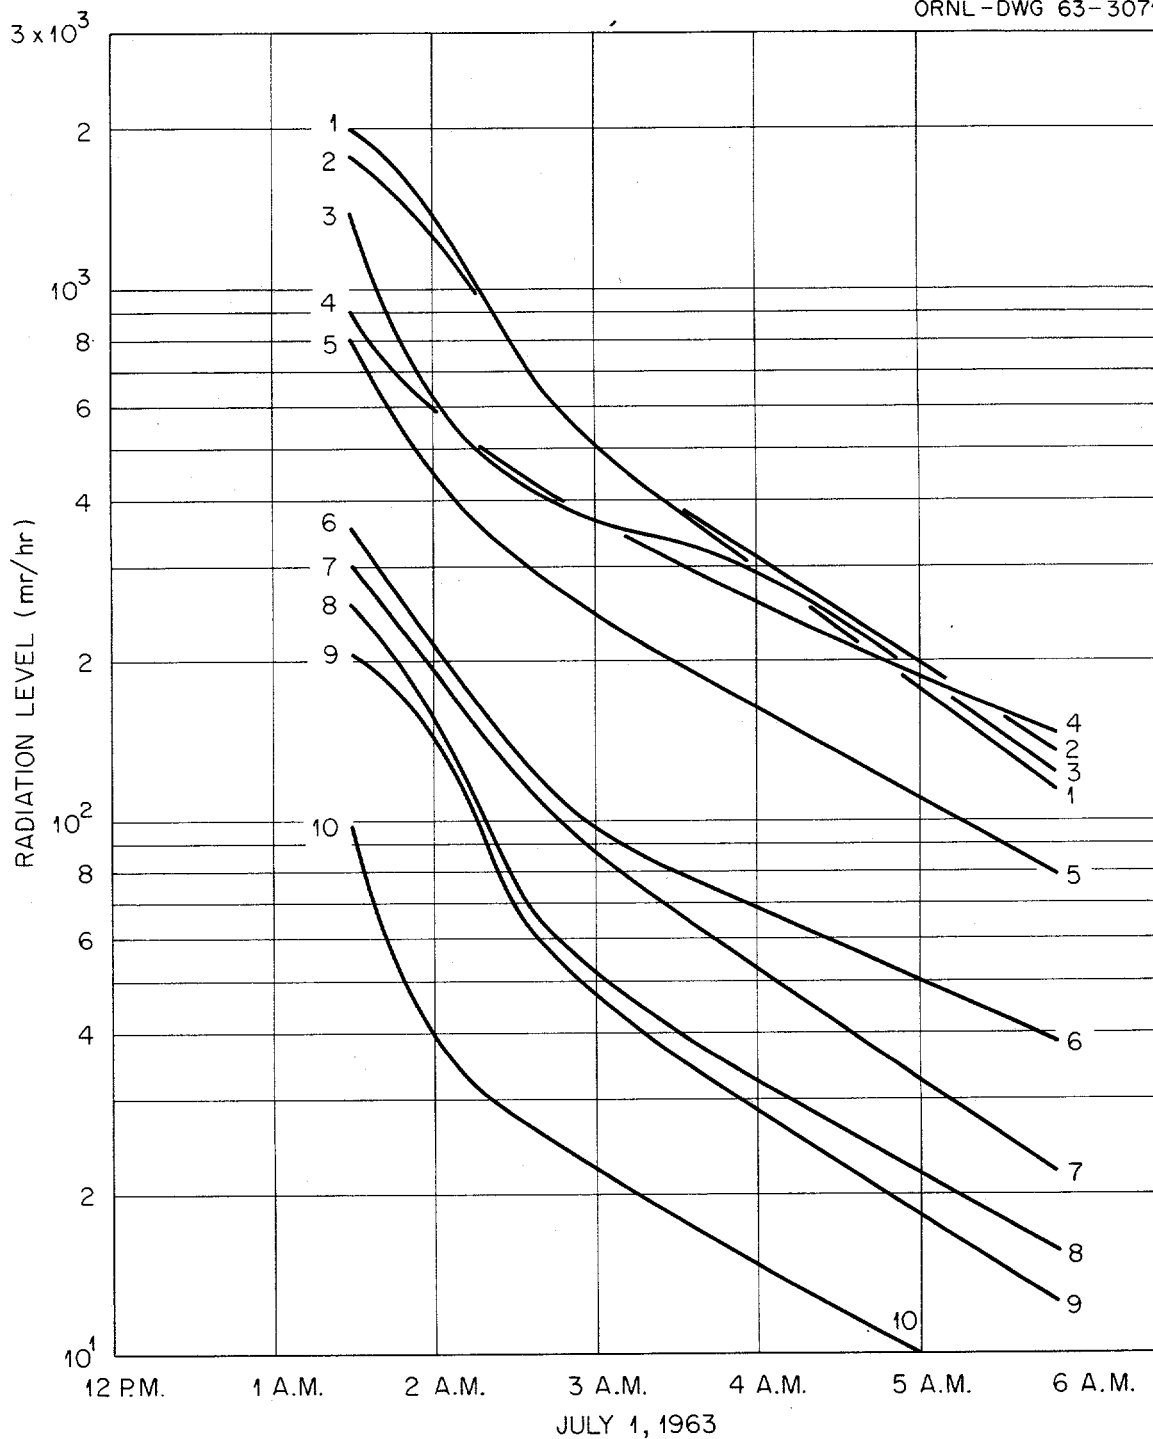
Fig. 7. Radiation Levels at Various Locations in the Reactor Coolant System

Radiation levels at various locations in the reactor primary coolant system outside the reactor building during the period from 1:30 AM to 5:15 AM, July 1, 1963, are shown in Figure 7 and Table 1. Figure 8 indicates the location of these components. Peak radiation levels measured were of the order of 10 to 20 times those normally encountered at 30 Mw.

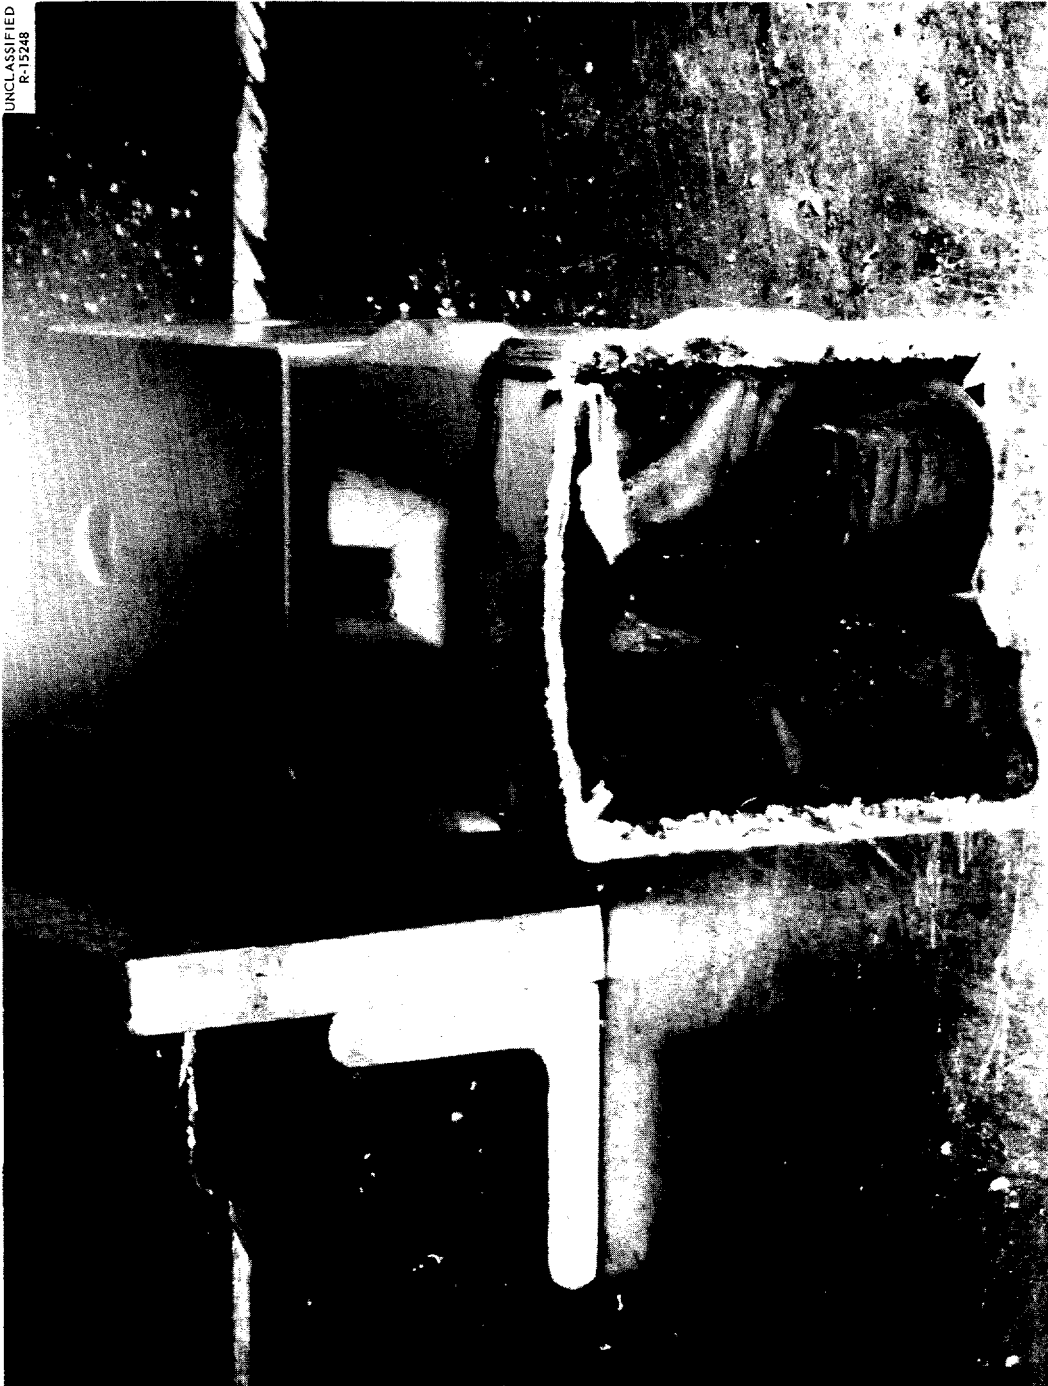
The element was transferred into the south ORR hot cell on July 5, 1963, to permit a visual inspection. Figure 14 shows a view of the blockage in the fuel element end box. The end boxes of the element were removed, and Figures 15 and 16 show the bottom of the end box containing the gasket. These view the surface of the gasket which was in contact with the fuel plates. Figure 17 is a photograph of parts of the gasket which were broken apart during its removal from the end-box section.

Fig. 15. Separated End Box from ORR Fuel Element OR-36C
Showing Gasket Material

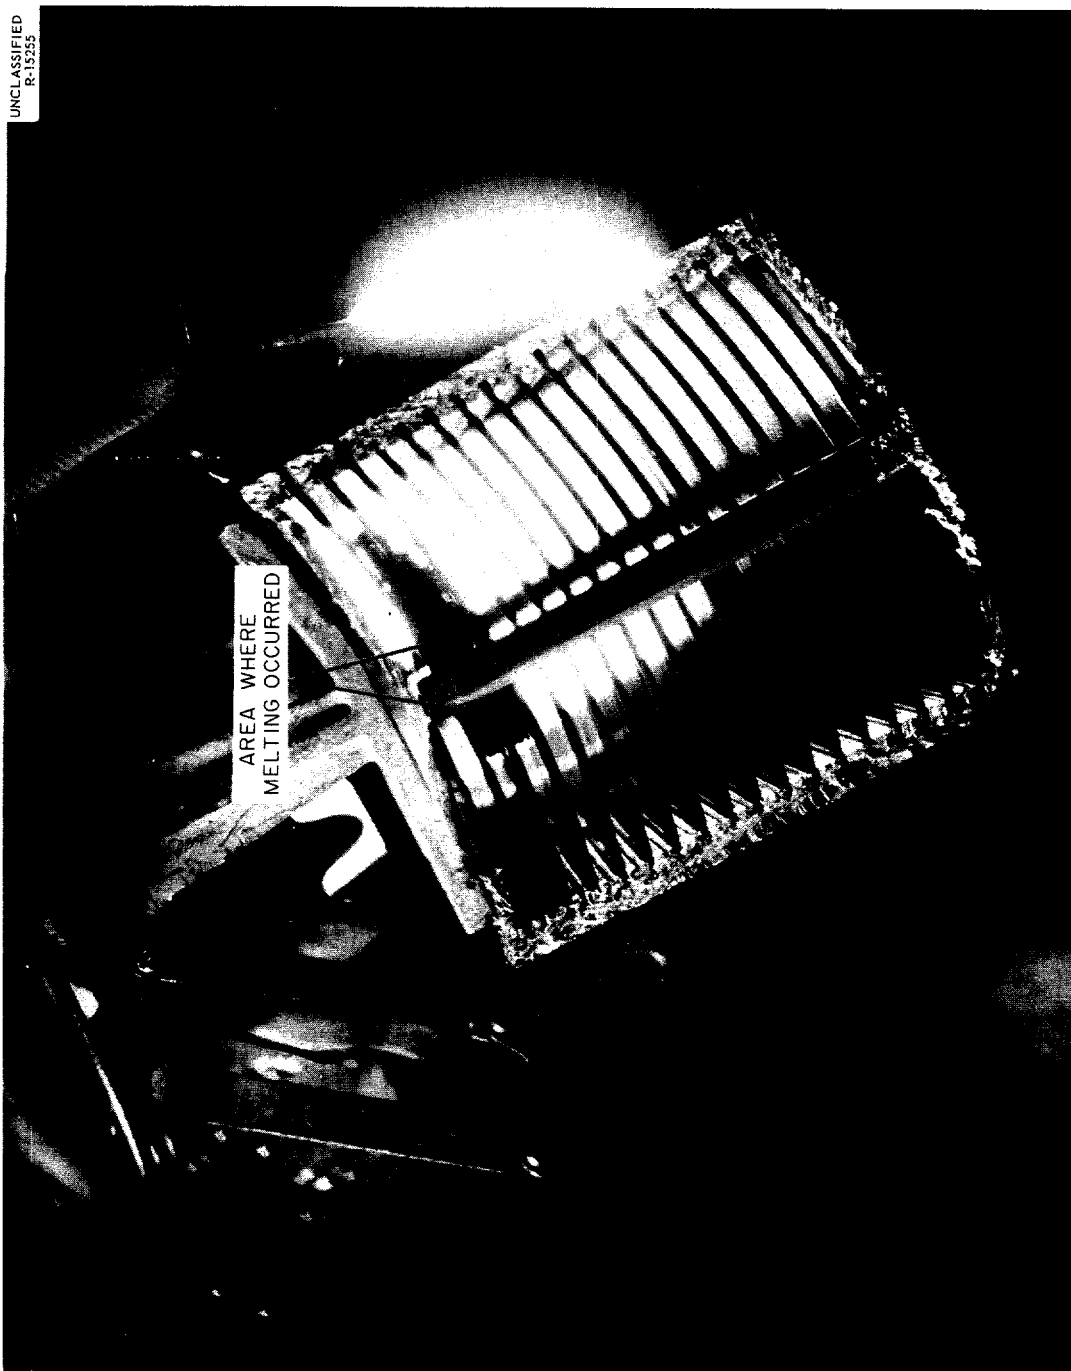
After the end-box sections were removed from the fueled section, visual inspections were made of the fueled section. Figure 18 is a photograph of the fuel plates taken from the bottom of the element. The darkened section between plates Nos. 2 and 3, and 3 and 4 (from the concave side) indicates the area where the melting occurred. Figure 19 views the fuel plates from the top. The "foreign" particles, with one exception, are cuttings from the disassembly of the end box. The dark material between plates Nos. 1 and 2, on the concave side, is a portion of the gasket material which adhered to the plates.

Fig. 18. Bottom View of Fuel Plates of ORR Element OR-36C

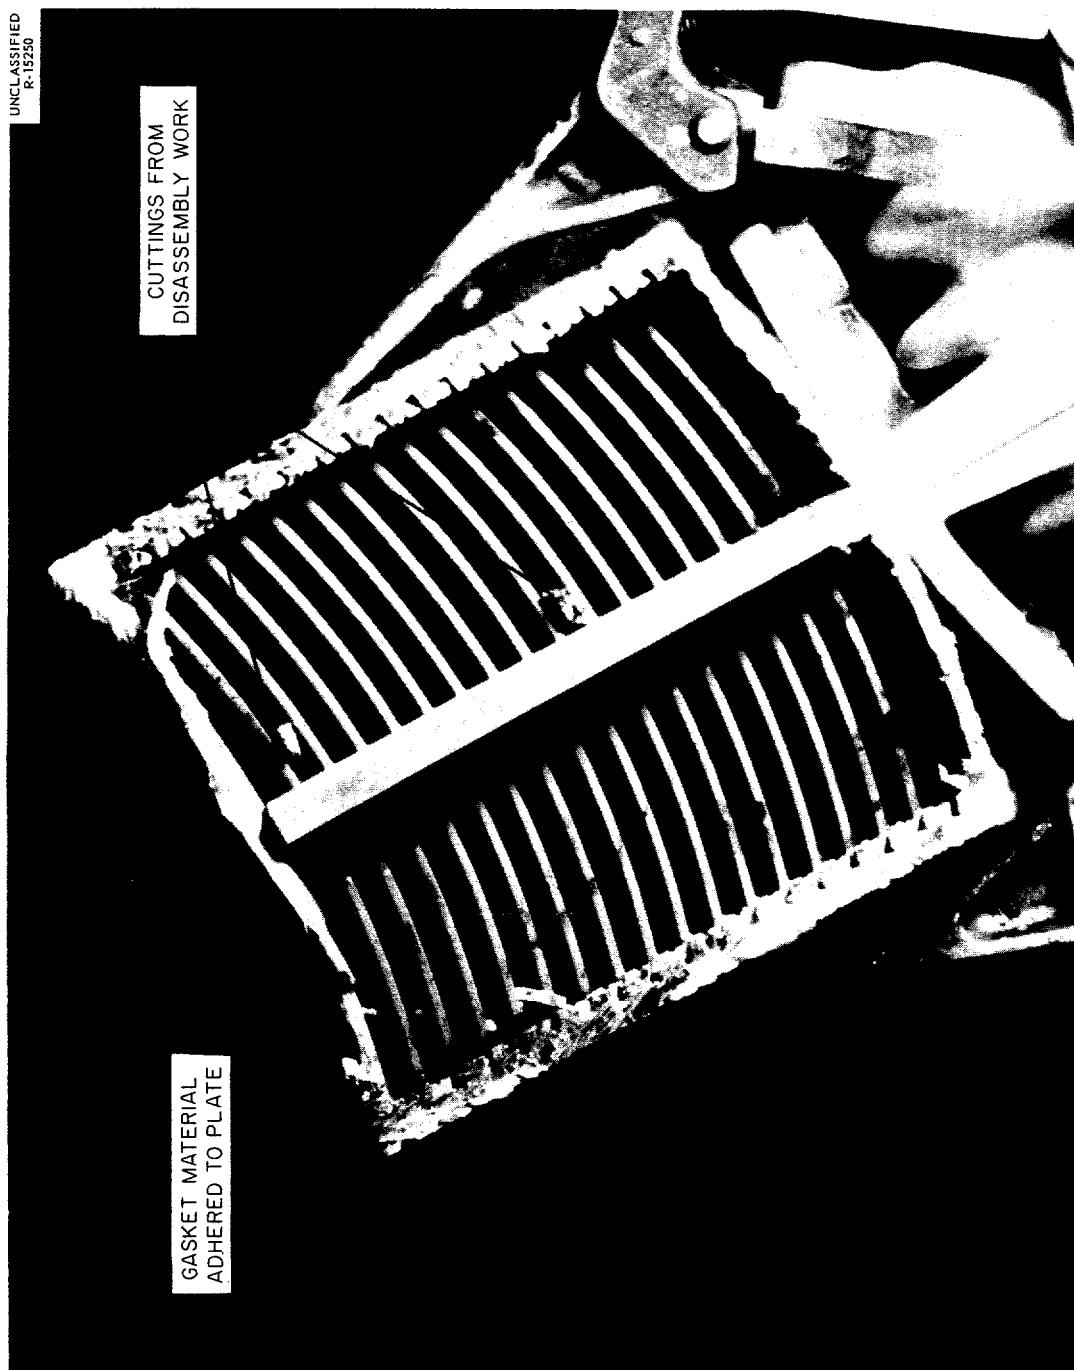
Fig. 19. Top View of Fuel Plates of ORR Element OR-36C

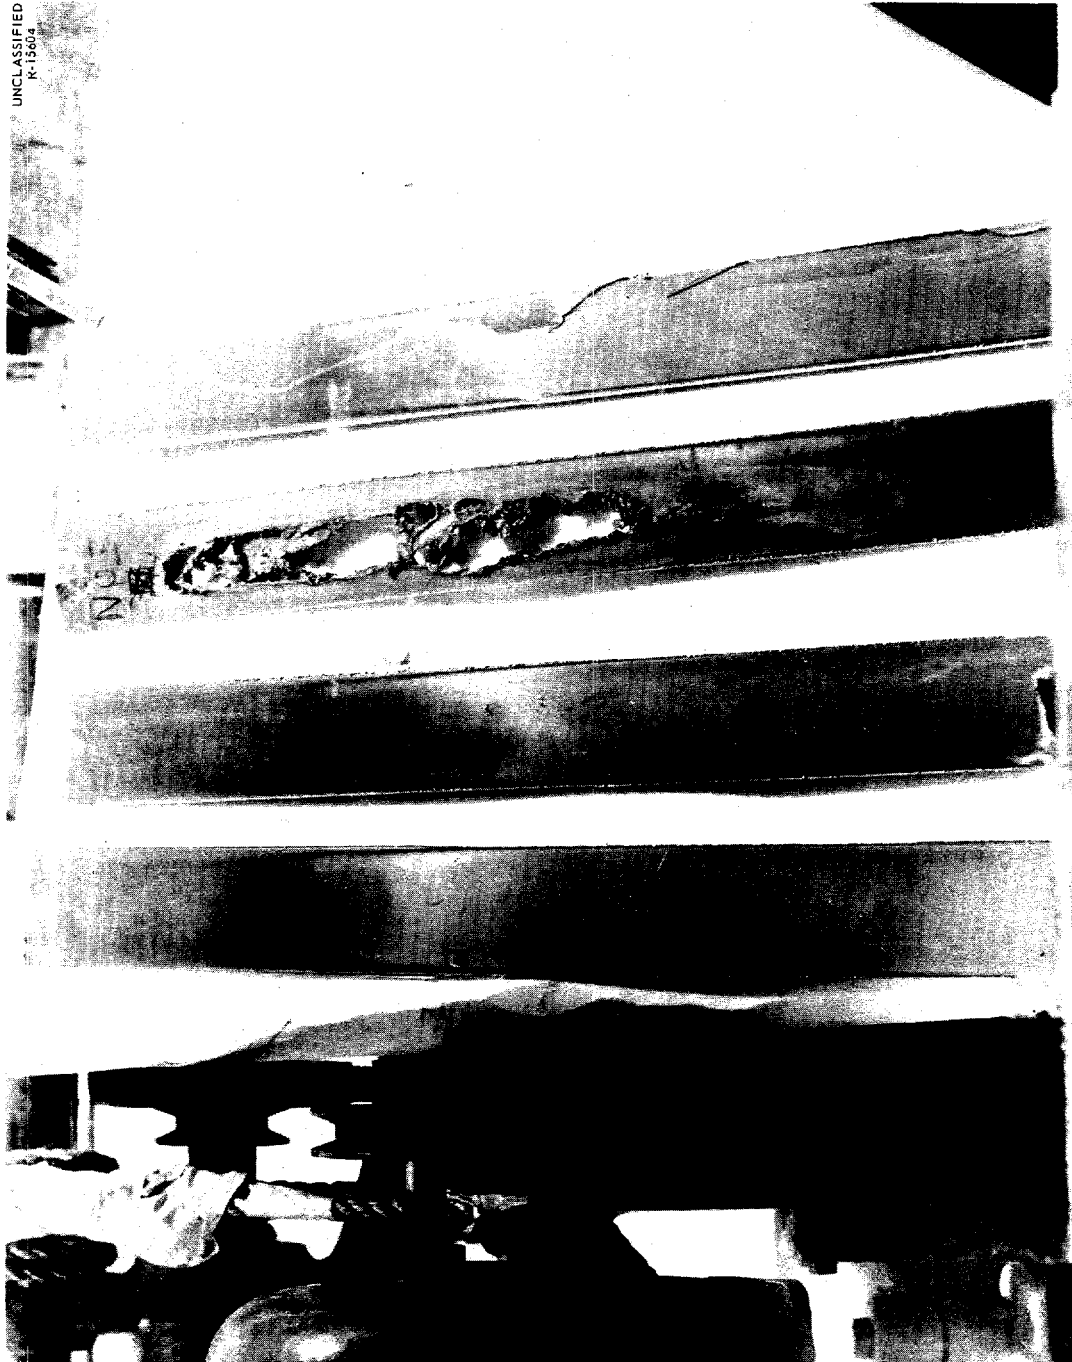
The fueled section of the element was transferred to a segmenting cell where the plates were removed. Each plate was visually inspected. Figures 20 and 21 show the plates after they were separated from the assembly. The melting occurred in the top section (as oriented in the reactor) of the plate. Visual inspections of the adjacent plates, as well as other plates in the element, did not indicate any surface damage although there was some discoloration.

Fig. 20. Convex Side of Plates from ORR Element OR-36C

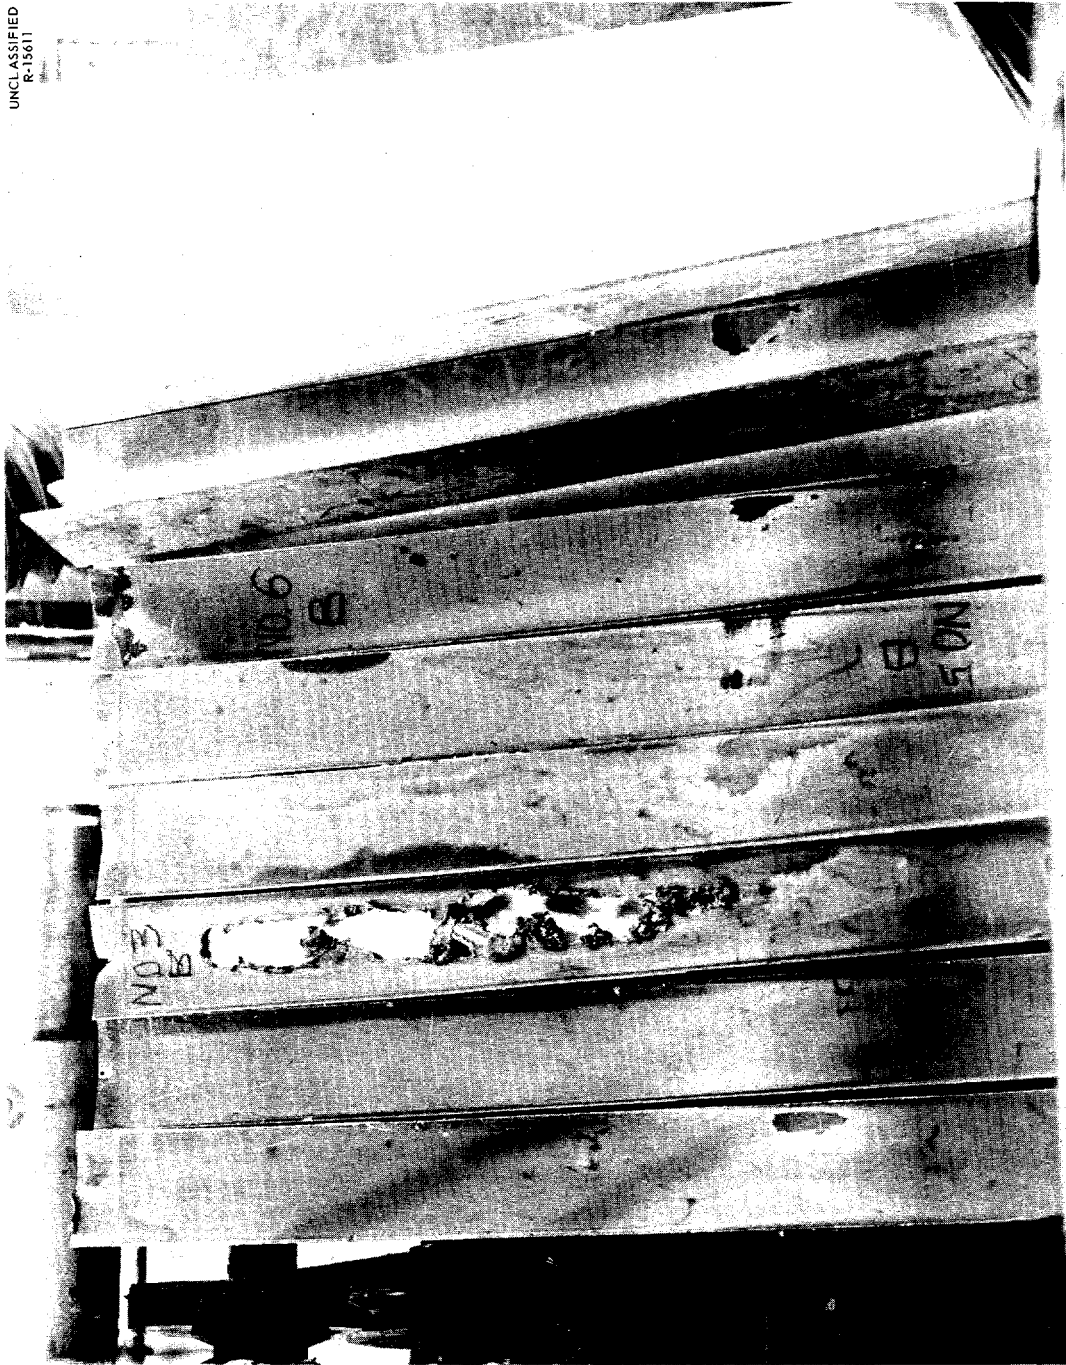
Fig. 21. Concave Side of Plates from ORR Element OR-36C
